# Pre-evaluating before maintenance

When performing maintenance on a leaky ball valve, there is a lot of information that must be evaluated before the actual maintenance is carried out. Part 12 in a series on the how (and why) of maintenance.

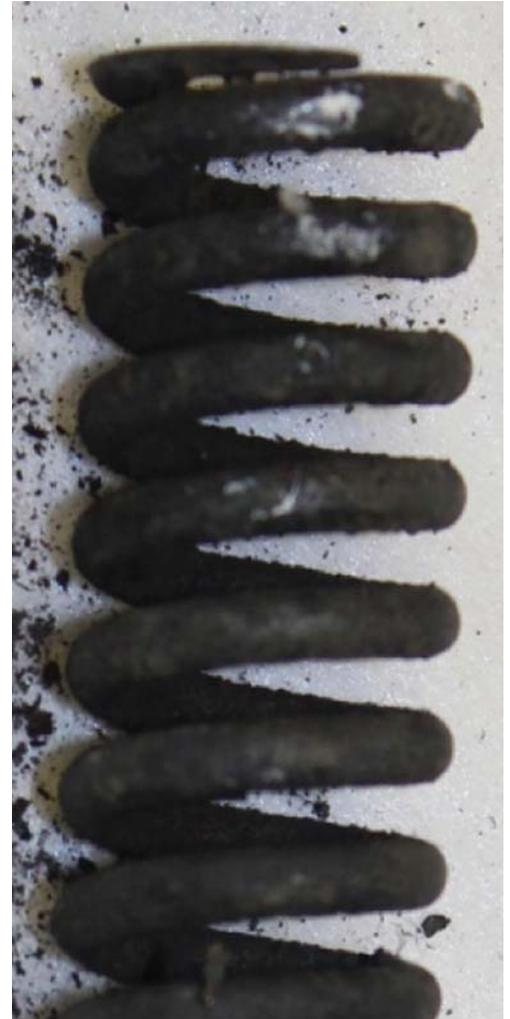
Figure 64

had tricked me as the O-rings were in perfect condition. But, as illustrated in Figure 66, the seal area on the seats was full of hard particles that were stuck on the seat. The particles were some 10th of a millimetre high and prevented the seat from coming into contact with the ball. We found the same black stuff in the spring pockets and on the coil springs, illustrated in Figure 64.

As the media was clean gas and condensate I was quite puzzled. I did clean the seats with valve cleaner and, as illustrated in Figure 67, the particles on the seal area were dissolved. It was decided to replace all internal parts, and the particles were sent to a laboratory for analysis. The result was: Under certain conditions (temperature and pressure drop) the gas molecules will bind in chains and transfer from gas to solid carbon and bind to the seal. I have never seen this before, but it taught me an important lesson: If the valve has been without maintenance, always clean it. It doesn't matter if the media has been clean. If we had cleaned the valve it would have been fixed and probably sealed 100%.

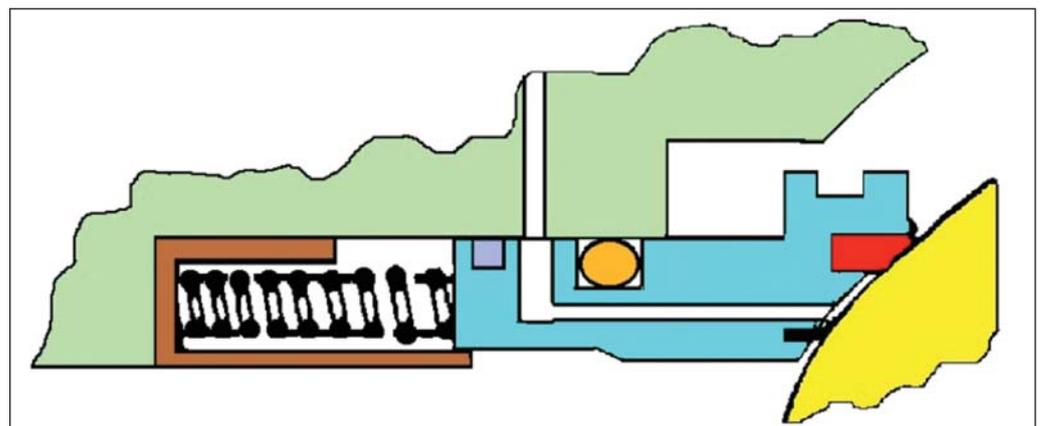
first barrier and should have been 100% sealed, but the valve was leaking too much. The valve information was as follows: Self-relief construction on the seats which sealed on the upstream seat only. As illustrated in Figure 65 the valve was equipped with soft-seated seats with PEEK

inserts. As also illustrated in Figure 65 the radial seals on the seats were O-rings. The valve was normally in the open position, operated only one or two times a year and had been in service for about 10 years. The valve was never closed in flowing condition or opened with differential pressure.

At the assessment phase there seemed to be a simple solution on the problem. My argumentation was as follows: not opened with differential pressure, not closed at a flowing condition and maximum operations 20 closures and 20 openings equals 40 of 90 degrees movement. With so few operations in a clean media and operating with a fully equalized valve I could not see any reason why the PEEK seal on the seats should leak. As the media was clean sales gas I did not think that deposits could be formed on the ball or seats. That argument was also based upon the fact that the condensate should actually work as a cleaner on the seal surfaces. My conclusion to this problem was that the O-ring on the radial seal of the seats may have suffered explosive decompression, or RGD, and the leak path was not between the ball and the seat but between the seat and the seat pocket, as illustrated in Figure 65. This could be fixed by injecting sealing component into the O-ring groove.

Because the conclusion in the pre-assessment was RGD in the radial O-ring we did not clean the valve with valve cleaner, but regarded that as a waste of time and valve cleaner. To the seal of the O-ring we injected a fair amount of sealing component, I even thought it was too much required to seal off the valve. We were unable to seal the valve 100% but we managed to get the valve nearly sealed off and kept the cavity without pressure by opening the auxiliary valve in the cavity. We managed to do the required job, but because of the relatively large leak rate passing the valve it was decided to repair the valve in the line (top entry valve). The whole system was shut down and depressurised to dismantle the ball and seats.
